# Manhole Inspection Summary

Manhole # S35YY1003MH

**Location** Address: **5223 PUTNEY WAY**

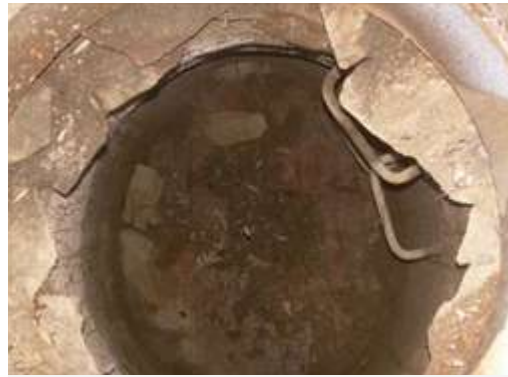
Top View

Channel debris.

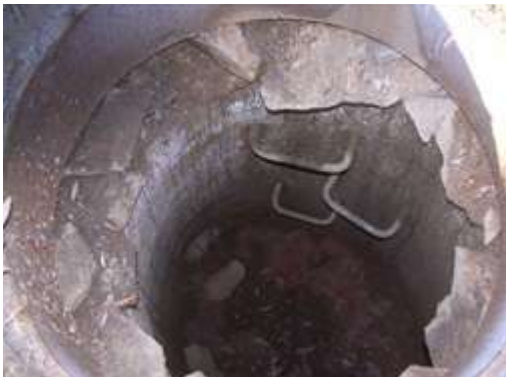
Defect

Frame leaks. Frame offset. Adjustment deterioration, loose brick and infiltration. Barrel infiltration - other side.

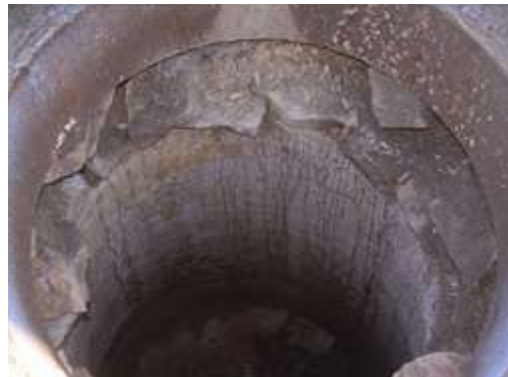
Defect

Frame leaks. Frame offset. Adjustment deterioration, loose brick and infiltration. Barrel infiltration.

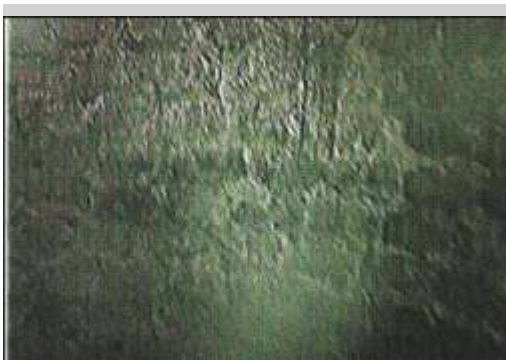
Defect

Barrel deterioration and infiltration.

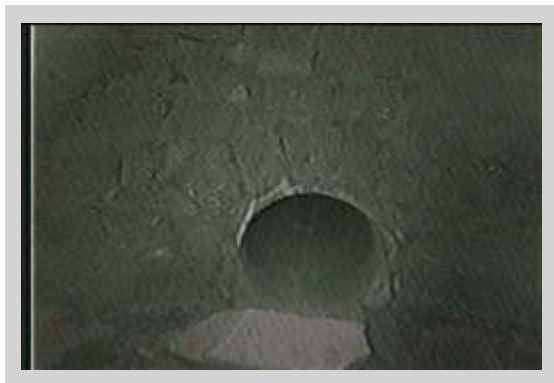
Pipe Out @ 12 O'Clock

Barrel deterioration and infiltration.
